## Management of failed direct restorations

**Mohammad AL-Rabab'ah**  
**BDS,MFD RCSire, MRD (Pros)**  
**RCSEd, JB(Cons),PhD**  
**University of Jordan**

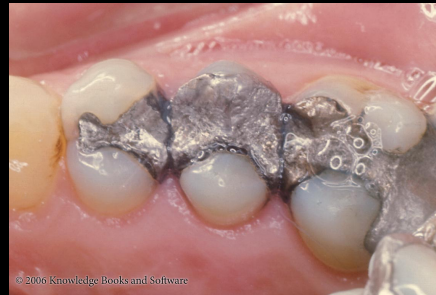
- Ditching

4	Fracture of an adjacent cusp is a relatively common occurrence in teeth with large amalgam restorations. Frequently the cause of fracture is mechanical trauma and the exposed dentine of the cusp base is sound.	Where there is fracture of a cusp adjacent to a large amalgam restoration and the cusp base is sound it may not be necessary to replace the entire restoration.
6	Fracture of a cusp adjacent to an amalgam restoration may result from secondary caries.	Where cusp fracture is caused by caries, partial/total removal of any adjacent amalgam restoration may be necessary to allow composite core removal.
6	If incorrect contouring of the contact area of an amalgam restoration leads to a complaint of pain/discomfort during eating or to bleeding on brushing or flossing, then modification should be considered.	Amalgam restorations with defective contact areas generally require modification.
7	Many patients notice the appearance of older amalgams which have corroded and discoloured adjacent tooth substance.	Amalgam restorations which have corroded margins should not necessarily be replaced, even if this is requested by the patient.

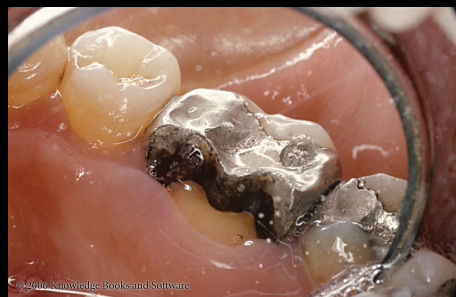
## Pitting

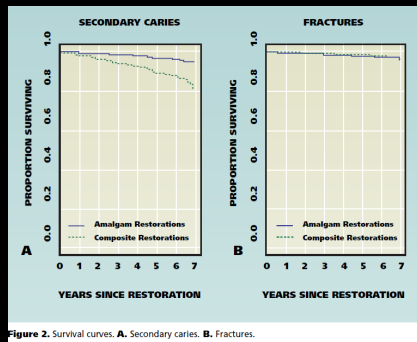
Figure 2. Survival curves. A. Secondary caries. B. Fractures.
